# Interlaboratory Comparison Report for the Community Environmental Monitoring Program of the Stibnite Gold Mine Project, 2021

*Idaho Water Resources Research Institute, University of Idaho, Moscow, Idaho, USA*

March 10, 2022

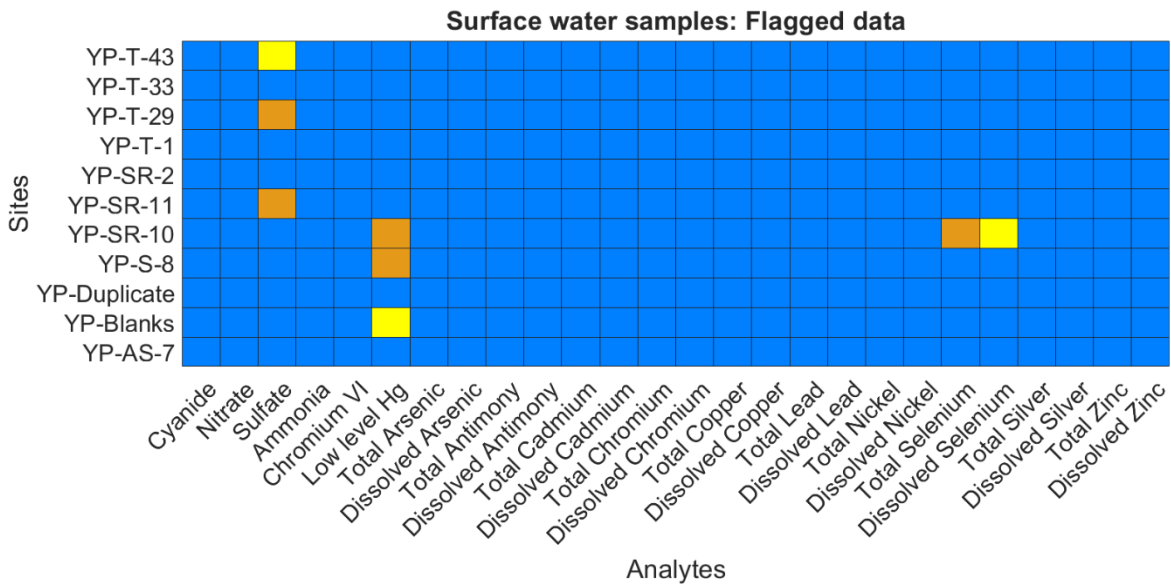
Figure 2. The flagged data points reported by Anatek Laboratory and SVL Analytical from and surface water sampling at Stibnite, Yellow Pine. The light-yellow cells represent cases where the estimate from Anatek exceeded that from SVL. The dark gold cells represent cases where the estimate from SVL exceeded that from Anatek.

The analytes and sites that correspond to the 3% flagged data are given in Table 7. Among the flagged data points (a total of eight water sample measurements), three water sample measurements were reported higher by Anatek in comparison to SVL, and five water sample measurements were reported higher by SVL in comparison to Anatek (Table 7, Figure 2).

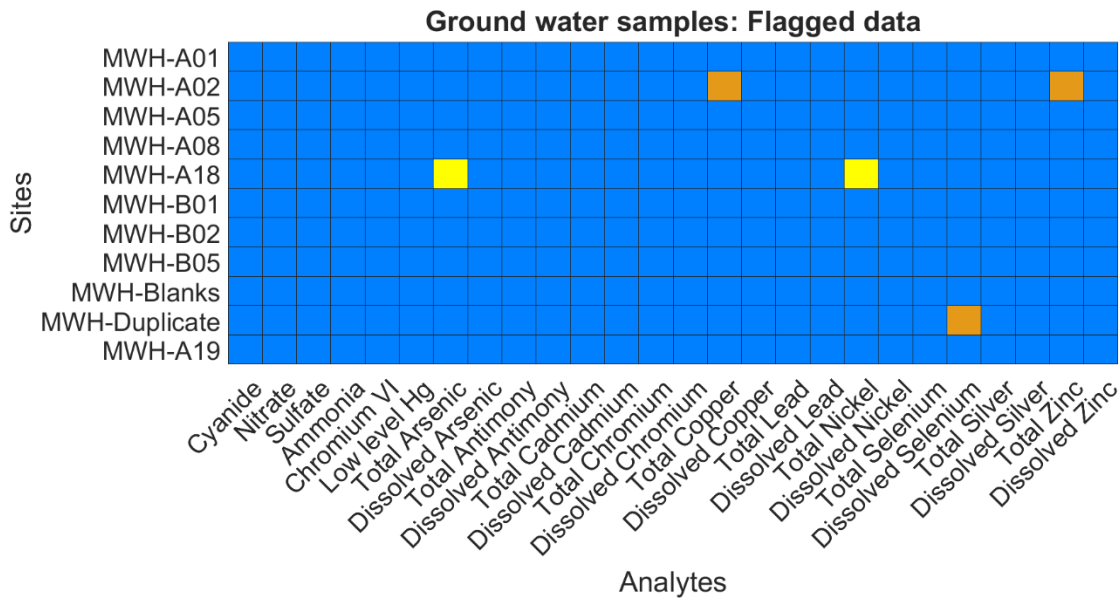
Figure 4. The flagged data points reported by Anatek Laboratory and SVL Analytical from and groundwater sampling at Stibnite, Yellow Pine. The light-yellow cells represent cases where the estimate from Anatek exceeded that from SVL. The dark gold cells represent cases where the estimate from SVL exceeded that from Anatek.

Table 8 shows the analytes and sites corresponding to the 2% flagged data. Among the flagged data points (a total of five water sample measurements), two water sample measurements were reported higher by Anatek in comparison to SVL, and three water sample measurements were reported higher by SVL in comparison to Anatek (Table 8, Figure 4).

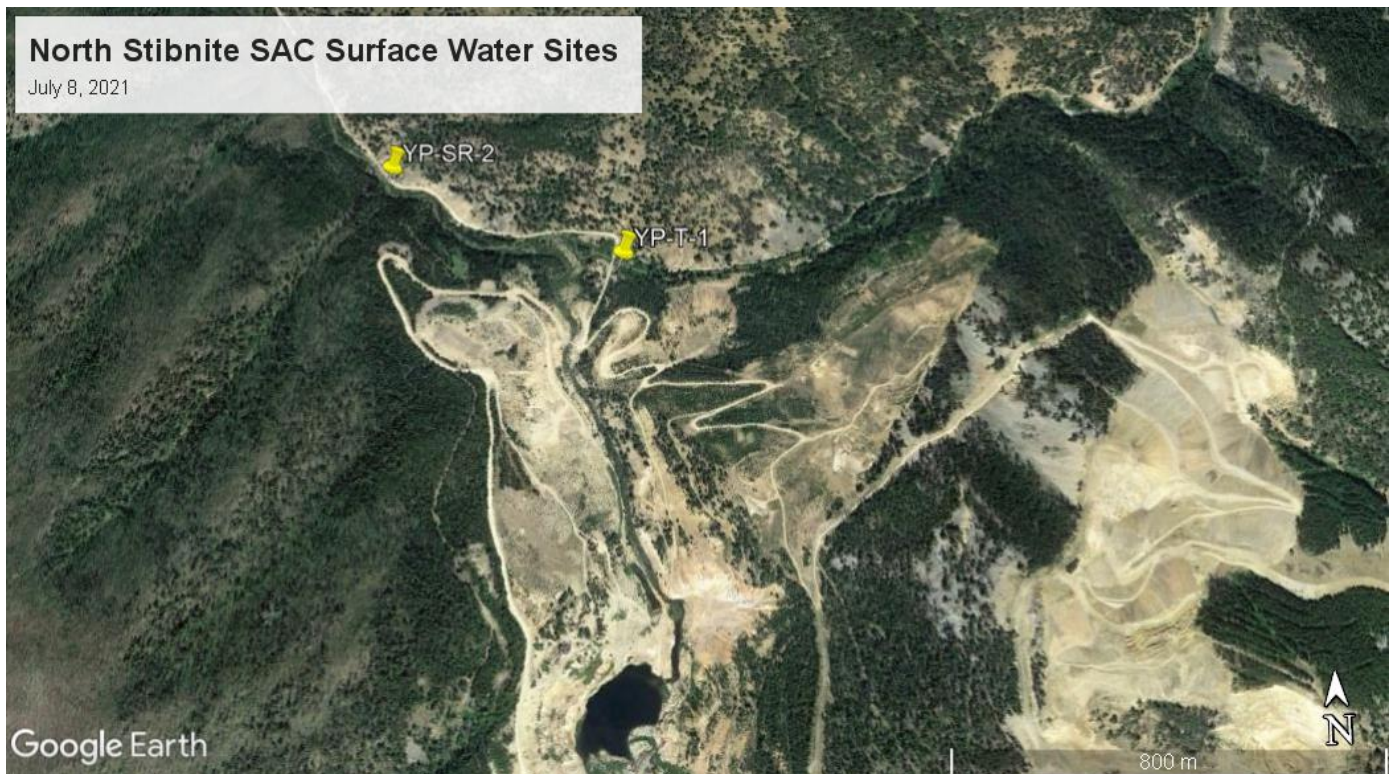
Appendix 2. Surface water sampling locations at the North Stibnite location

Surface water samples were collected on July 29th, 2021, at 11 sites (Appendix 1-2). The site nomenclature is listed in Table 2. The total number of analytes quantified was 25, and therefore the total number of samples

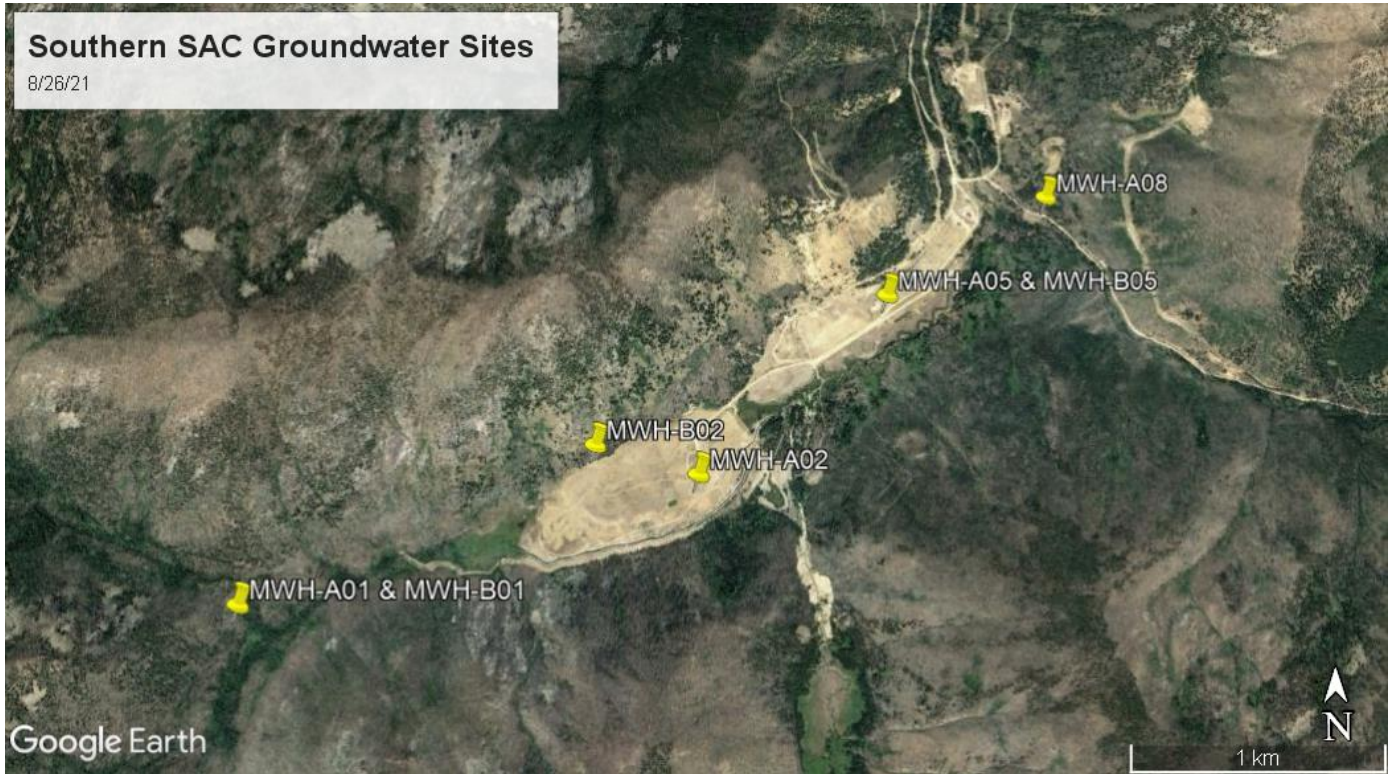
Appendix 3. Groundwater sampling locations at the South Stibnite location

Groundwater samples were collected on August 26<sup>th</sup>, 2021, at 11 sites (Appendix 3-4). The site nomenclature is listed in Table 3. The total number of analytes quantified was 25, and therefore the total number of samples taken from 11 sites sums up to 275. Similar to surface water sampling, one site was a duplicate and another a blank site. The duplicate sample corresponds to a second set of samples collected from a selected site, which in this specific case was site MWH-A08, Alluvial well east of EFSFSR and Meadow Creek confluence. The blanks sample corresponds to using distilled water in filling the bottles, which in this specific case was collected at MWH-A18, Alluvial well North of the EFSFSR, across the river from the Bradley dumps. The site selection for both duplicate and blanks were random to validate the data reported by two laboratories.

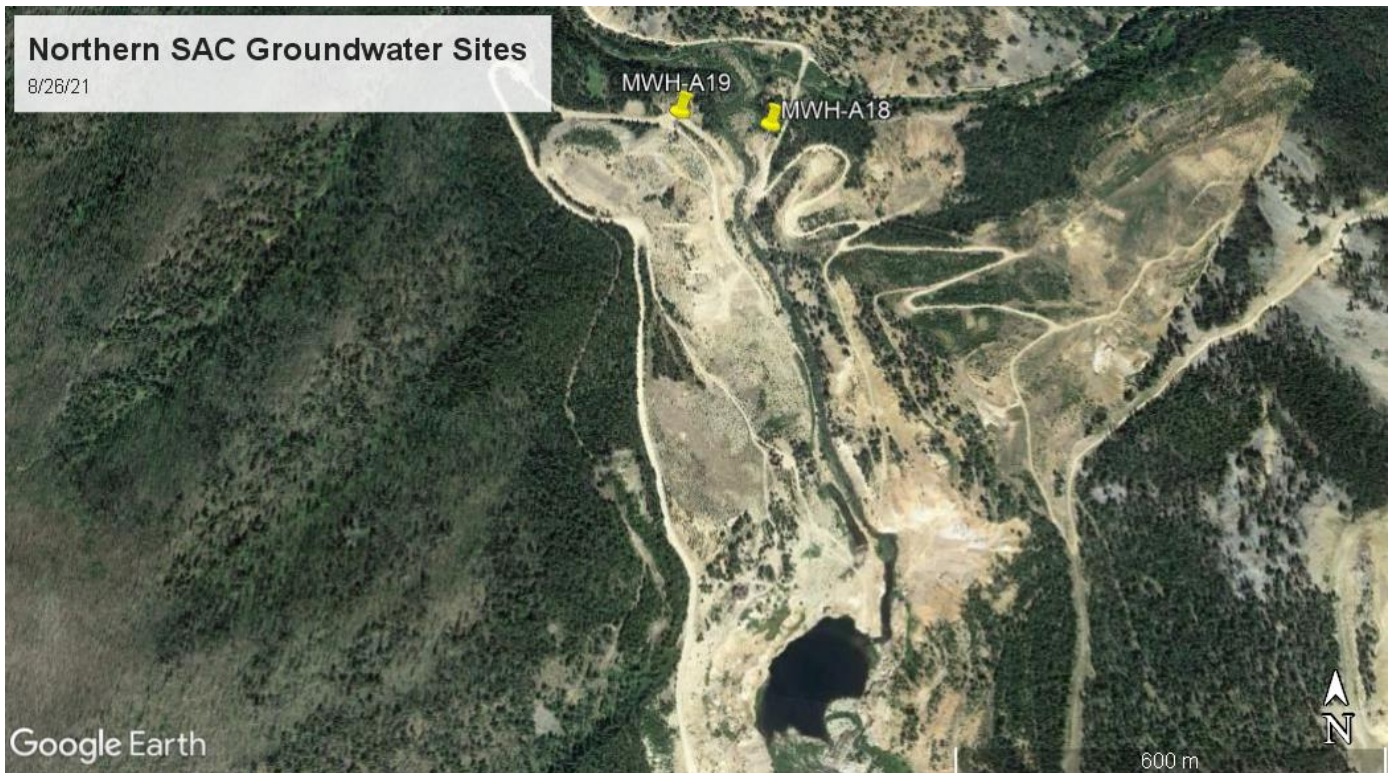
Appendix 4. Groundwater sampling locations at the North Stibnite location
